**THE PARISH CHURCH
OF
ST JOHN THE BAPTIST
WESTWOOD HEATH
WARWICKSHIRE**

**QUINQUENNIAL INSPECTION REPORT
FEBRUARY 2020**

UNDERTAKEN BY MARK EVANS

MARK EVANS ARCHITECT LTD

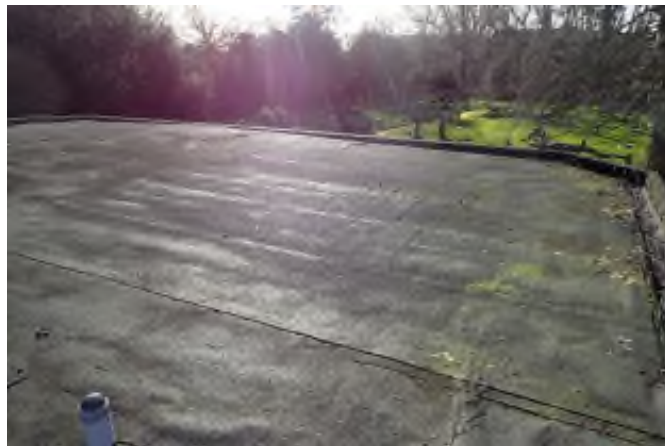
Church Hall Roof

- 2.1.20 There is a perimeter mineral felt parapet gutter which drains to roof outlets and on into internal downpipes. To the lower section of roofing there is a central gutter which drains to an internal downpipe. The condition and effectiveness of the internal downpipes is not known but there are no known problems.

- 2.1.21 As reported in 2009, the roofing felt contains numerous large and small areas of bubbling indicating that there is water below the felt. It is not known whether this problem is a result of the roof being laid on a damp substrate, water vapour rising from the internal rooms or water penetrating the roof covering. The condition of the roof covering seems similar to as previously viewed and will eventually hole. Repairs should be expected.

- 2.1.22 As reported in 2009, no visible splits in the felt were seen and there are no known major leaks to the roof. Whenever the roof is walked upon the felt will be damaged and in due course bubbles will lead to splitting and ingress of water. When the felt is next opened up the roof boarding and roof void should be inspected for evidence of water damage/condensation and for evidence of a vapour barrier.

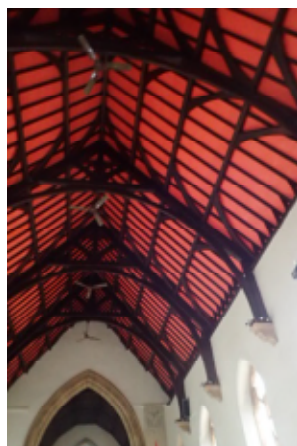
Nave Ceiling

- 3.1.4 The ceiling panels seem similar to as previously viewed although there appear to be more areas of water disruption to the plaster surface and this is visible in numerous locations. How many of these disruptions are new over the last six years or pre-existed would need careful review of previous photographs but the sense is that there are notably more now. However, no misaligned ceiling panels were seen and the main areas of cracks and previous decay are as previously reported below. *‘However, the security of the plaster is always uncertain and localised leaks or wind disturbance can cause unexpected falls of plasterwork. Towards the south west area, a section of ceiling plaster has previously fallen (May 2008) and it is understood that an area to the north was previously repaired. Decayed laths are visible to the area of collapse. To the north side, second bay from the west the ceiling is water marked but the plaster is not cracked or*

misaligned. It is understood that this is of long standing and the cause has previously been addressed. The condition of the ceiling has not apparently significantly deteriorated during the preceding five years'.

- 3.1.7 Ceiling panels are coloured red/orange. As previously reported, the decorative material used on the ceiling is not known. There is some cracking to panels, none appear to be of particular concern at present, but should be monitored. Some sections of ceiling have water marking which appears to be condensation marking rather than penetrating water. Condensation was visible on some north windows and the church space is significantly colder than the church hall, which is on a separate heating circuit/system. The condition of the ceiling seems similar to as previously viewed but this does not negate the need for its close inspection. It may also be prudent to consider installing discreet netting, fixed to the rafters, so that any plaster which might fall would largely be retained by the netting.

- 3.1.5 It is recommended that the ceiling is regularly visually inspected in case sections of plaster become cracked or misaligned and are therefore addressed prior to any localized collapses. This has previously been advised and remains valid, particularly given the ongoing decay to the lath fixings. It may also be prudent to consider installing discreet netting, fixed to the rafters, so that any plaster which might fall would largely be retained by the netting.
